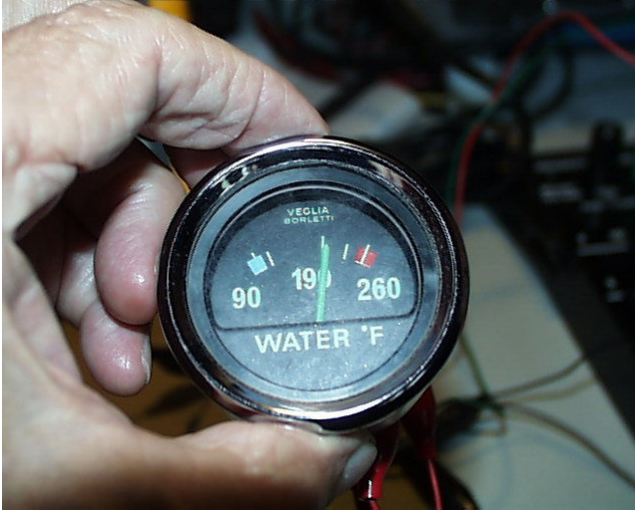
Fig. 1 shows a Pantera temperature gauge with one ohm of resistance between the gauge housing ground connection and the sensor ground connection and the gauge illumination lamp OFF.

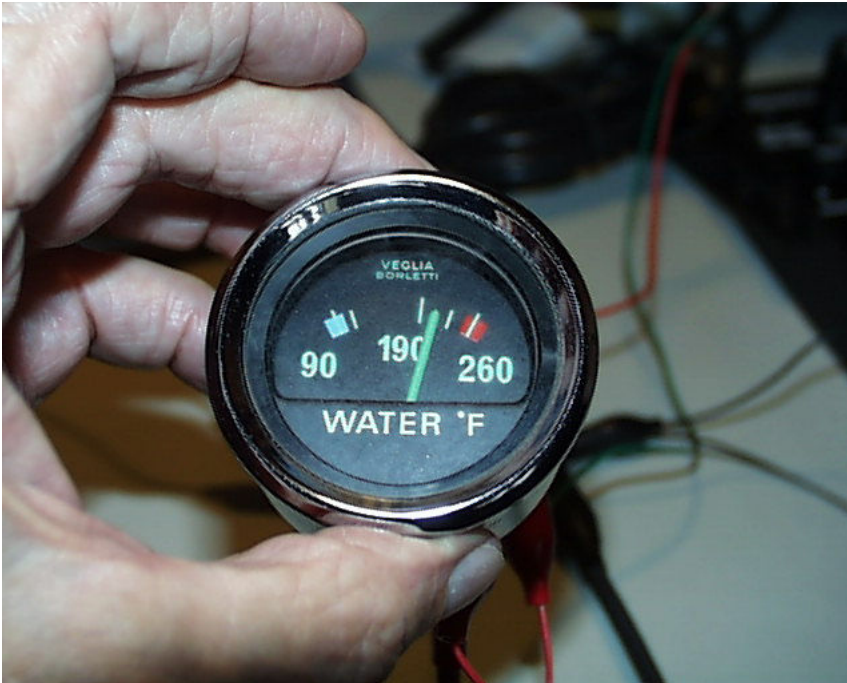
Fig. 2 shows the same gauge with one ohm of resistance between the gauge housing ground connection and the sensor ground connection with the gauge illumination ON. The upscale movement of the gauge indication is caused by the approximately 0.200 amp lamp current flowing thru the one ohm ground resistance.
