Rust proofing the Pantera chassis

I enlarged the chassis drain holes and rust proofed the inner frame rails, suspension mount points (horseshoe area), and body seams in the front of each rear quarter panel (behind the gas tank) and against the B-pillar (back of door jamb).

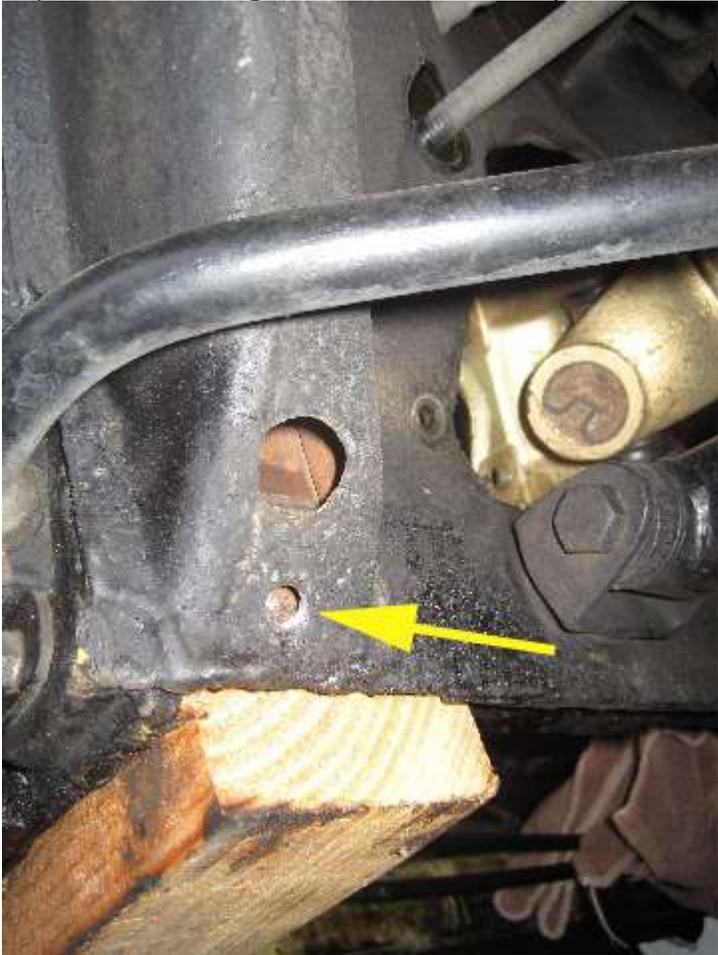
Added an additional drain hole at the bottom of this structural frame member to ensure any moisture that got in here would easily drain out.

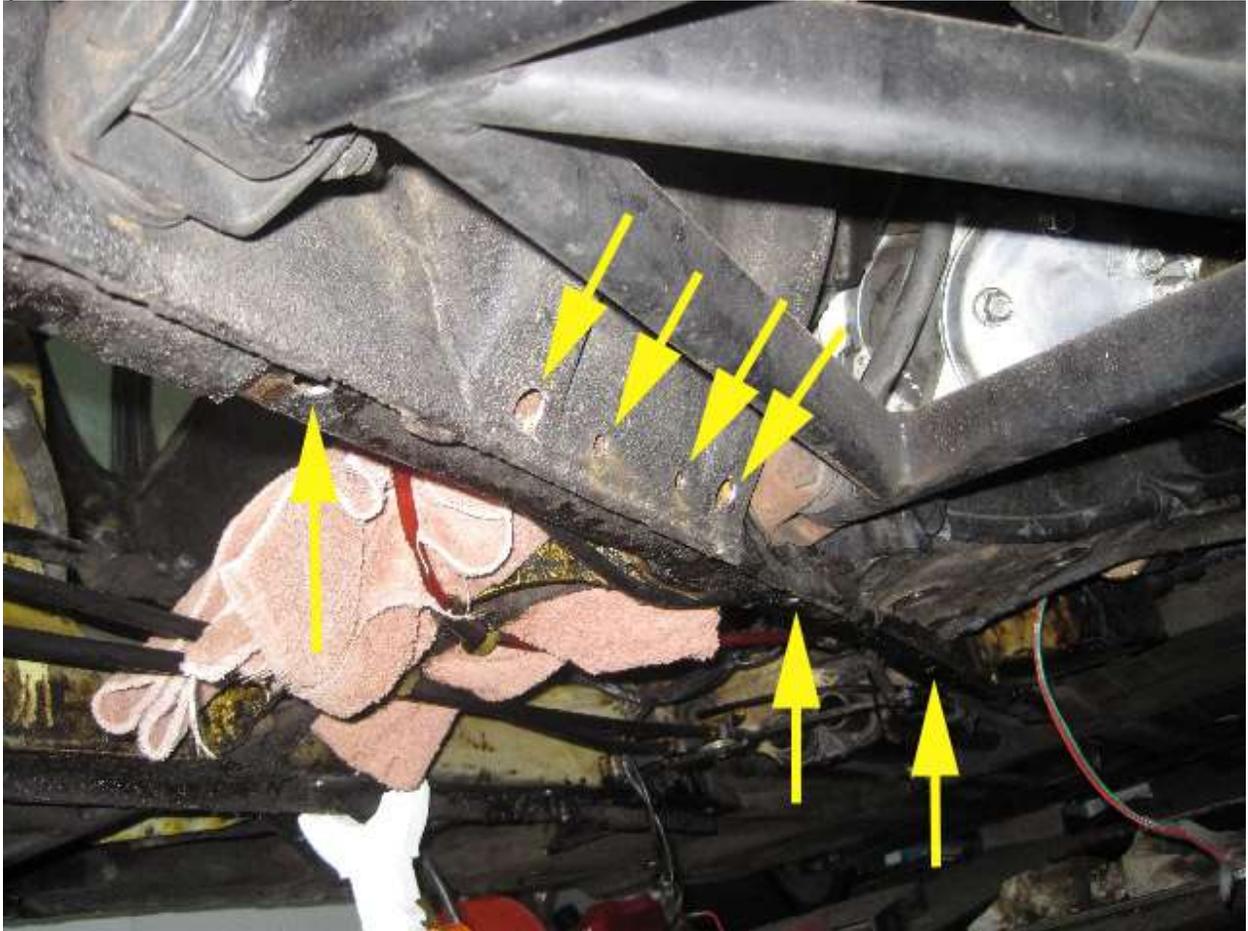
I enlarged the factory drain holes at the base of the vertical frame structure in the rear wheel house, and added 1/2" drain holes in the lower frame rails per Jack DeRyke's article (downloadable above).

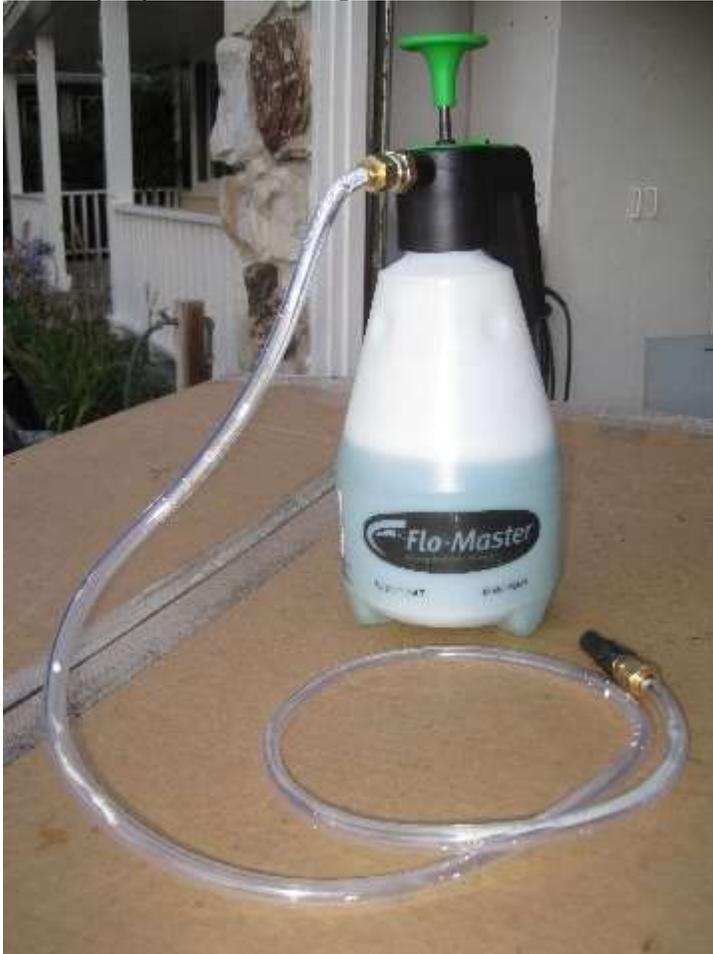
I made a simple spray apparatus with a \$6 sprayer from Home Depot, some 3/8" hose, a couple of brass fittings to secure the hose to the sprayer, and a fan spray tip from an old weed sprayer that no longer works.

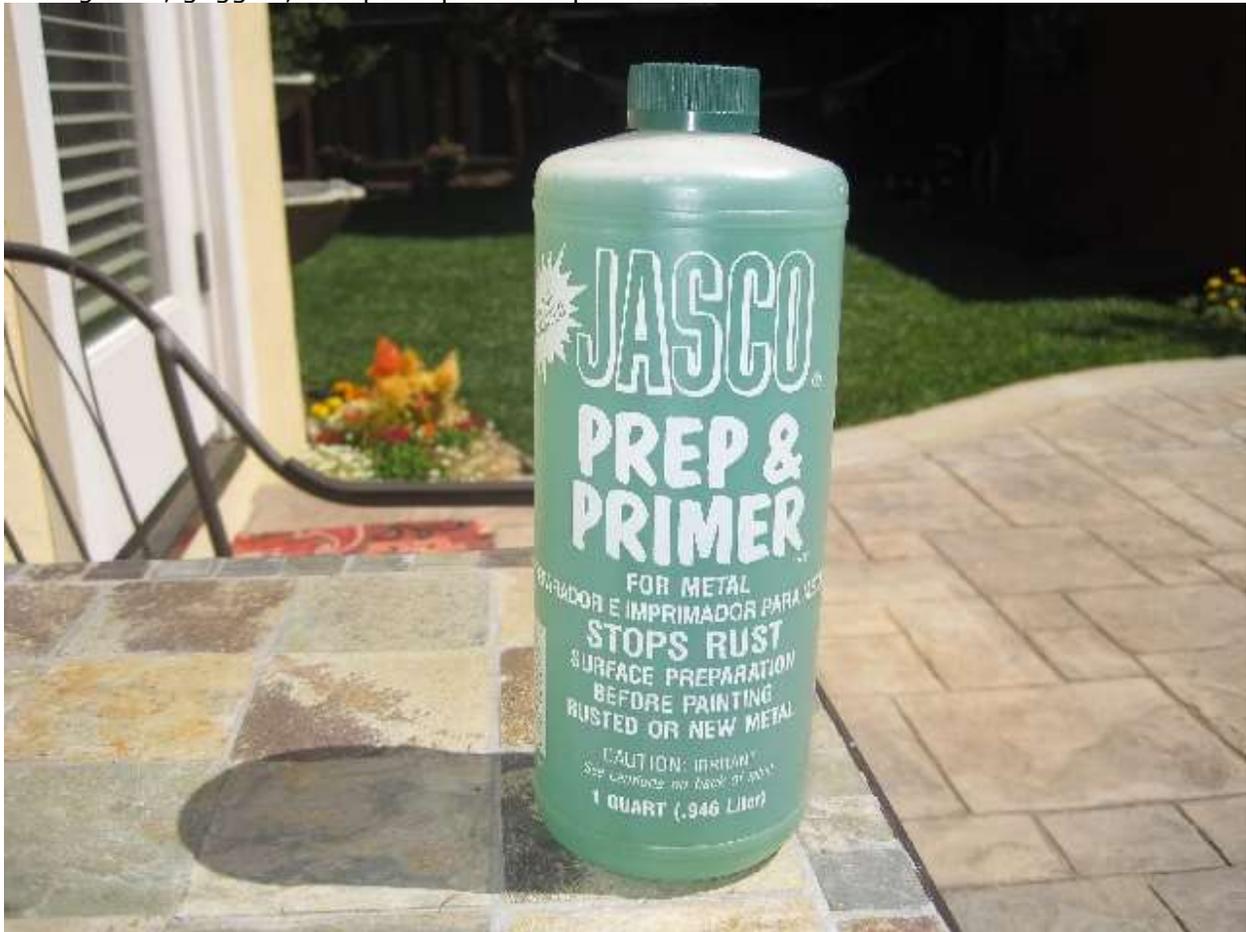
I then sprayed the inner frame rails with Jasco Metal Prep which converts rusted rust from ferrous iron to iron phosphate and prepares the metal surface for paint. The Jasco costs about \$6 at Home Depot, which is a far bit less expensive than the same designer label products from Eastwood.

To apply, I would insert the spray tip into a frame rail as far as it would go, then spray while slowly pulling the hose back to assure complete and even coverage of all interior surfaces. Do this in both directions from each side where you have access. I inserted the spray hose up into the wheel house horse shoes from the engine compartment side and performed the same procedure on both sides.

I then applied Eastwood's "Rust Encapsulator" to protect against any future corrosion. Here's a picture of the area behind and in front of the gas tank after treatment, This area is notorious for rotting through from the inside since dirt, gravel and moisture all get trapped between the gas tank and the body panel.
